# Impact of bank material on channel characteristics: A case study from Tripura, North-east India

Nibedita Das and Sudatta Wadadar

*Department of Geography and Disaster Management, Tripura University, Suryamaninagar, Tripura (W)*

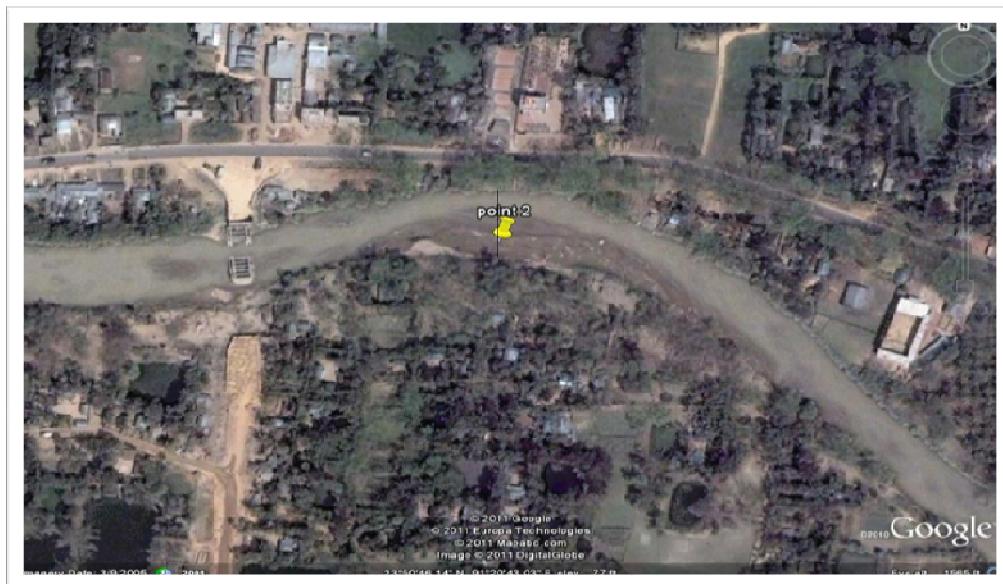
Plate 1: Cross-section site at Khayerpur (23°50.770'N, 91°20.709'E)

At this site a wide mid channel bar is visible with a width of 14.25 m. The depth of water is very shallow (only 0.24 m) in both sides of the bar (highest depth in the left of the bar is 0.56 m, and highest depth at the right of the bar is 0.53m). The left bank has a steep slope, i.e. 65°, the right bank has a gentle slope and this bank has some breaks in slope. The average slope of the right bank is 28°37.3'. As the field survey was carried out during pre – monsoon season, there was lack of water in the river and huge

Less cohesive bank material i.e., sand dominates the middle and bottom of the bank, leads to maximum erosion which ultimately leads to failure of the upper bank. This process is directly responsible for the increase in channel width and channel accretion in the downstream.

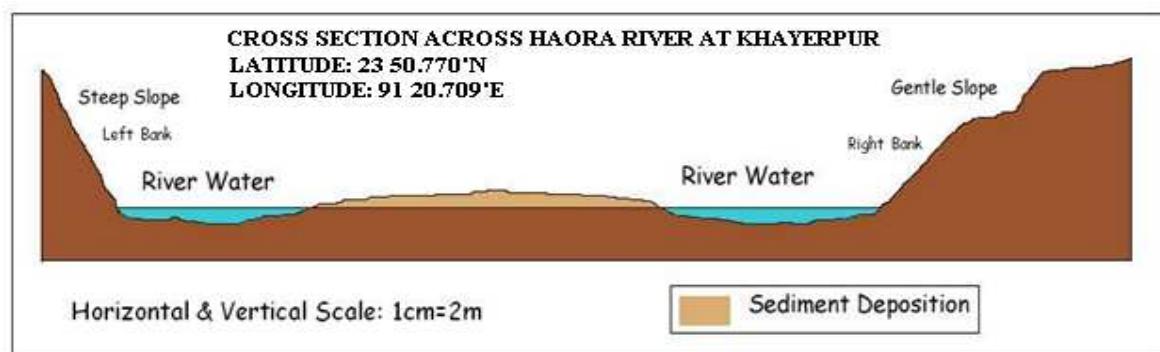
Fig. 2: Cross-section across the Haora River at Khayerpur

Season : Pre-monsoon
Water width : 20 m
Average Depth : 0.24 m
Cross Sectional Area : 4.8 m <sup>2</sup>
Wetted Perimeter : 16 m
Hydraulic Radius : 0.3 m
Sediment Load : 165 mg / l

channel deposition prevalent. Cross-sectional area (W\*D) is only 4.8 m<sup>2</sup>, wetted perimeter (length of contact between water and channel bed and bank) is 16 m which means less water is in contact with the channel, so friction from the bed and banks is reduced. Hydraulic radius (cross sectional area / wetted perimeter) is 0.3 m which means the river is aggrading in character.

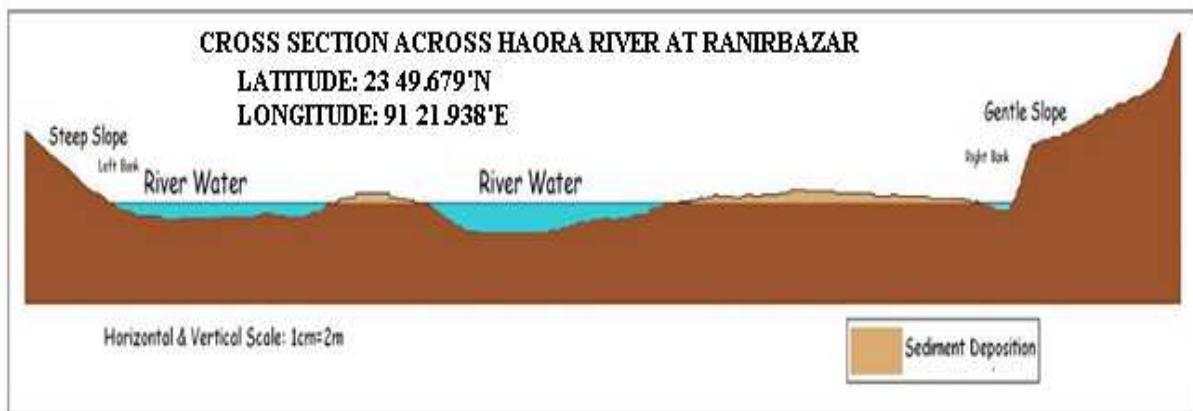
Fig. 3: Cross-section across the Haora River at Ranirbazar

Season : Pre-monsoon
Water width : 24 m
Average Depth : 0.0152 m
Cross Sectional Area : 0.36 m <sup>2</sup>
Wetted Perimeter : 13 m
Hydraulic Radius : 0.028 m
Sediment load : 124 mg / l

In this profile two mid channel bars are present. Amongst them one is small with a width of 3.4 m and the other is large with a width of 13.6 m. At the right bank the signs of human intervention are prominent. From the profile it is seen that water is present at the right bank just like a pool. It is formed due to human intervention through continuous collection of sand from the river bed. The slope is also cut off by the people in the right bank. Therefore an abrupt change in slope is found. The right bank has a gentle slope of 27° whereas the left bank is steeper with an angle of 47°40'. Here the river is extremely shallow (0.0152 m) and therefore all hydraulic variables show very low values. Wetted perimeter is 13 m and cross sectional area is only 0.36 m<sup>2</sup>. 0.028m hydraulic radius indicates very high aggrading character of the river at this cross-sectional point.

At Ranirbazar site, soil texture in the middle portion of the bank is loamy sand type as at Khayerpur. But the practice of sand collection using machine leads to the deepening of the channel (4-5 feet) at both the banks and thereby weakening of the bottom of the banks where sand is the dominant particle. In this way channel becomes wide through bank failure.

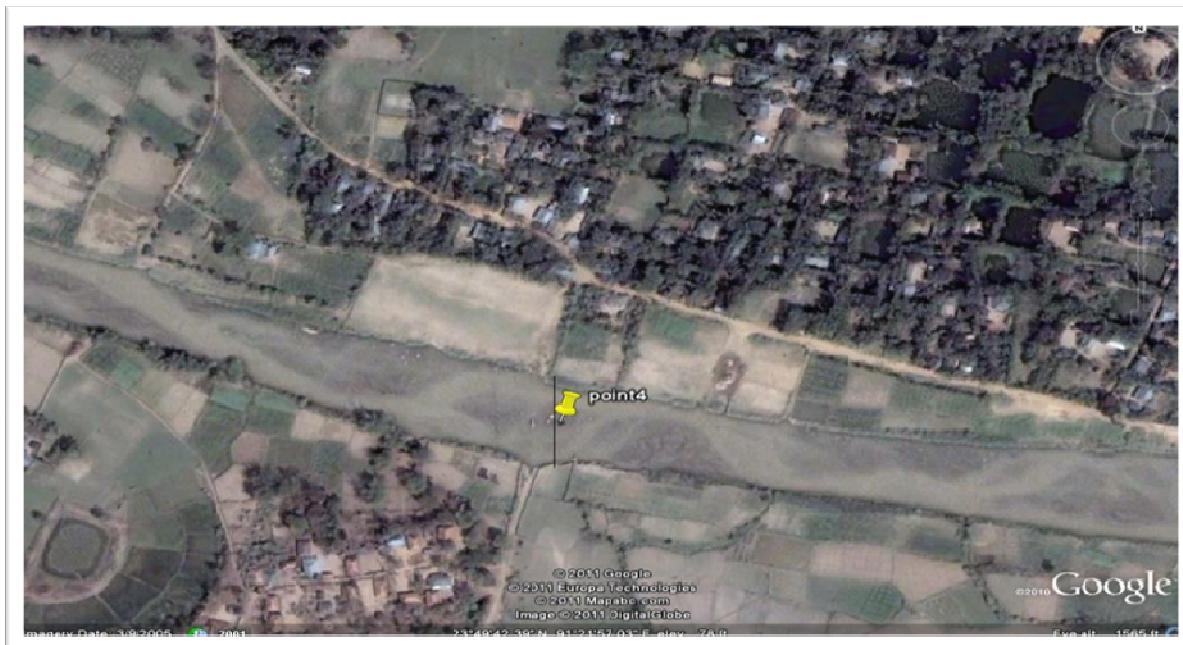
Plate 3: Cross-section site at Mekhlipara (23°49.864'N, 91°21.639'E)

In this profile the biggest mid-channel bar with a width of 14.50 m is found. At the right side of the bar, depth of water is comparatively more (1.18m). The height of the bar from water level is 0.52 m. The right bank is steep with an average angle of 56°40' whereas the angle of the left bank is 33°30' i.e., gentler than the right bank. Though Mekhlipara is located 3.46 km upstream of Khayerpur, still the River Haora is wider at Mekhlipara (36.75 m) than at Khayerpur (30 m).

The reason is the widening of the channel through bank erosion along the right bank due to the presence of less cohesive materials as evident from the soil sample collected from the site and tested and then analysed. Cross sectional area (12.40 m<sup>2</sup>), Wetted perimeter (20 m) and hydraulic radius (0.62 m) – all are higher at Mekhlipara compared to Khayerpur. Higher wetted perimeter indicates that at this cross-sectional point comparatively more water is in contact with the river bed and so friction of water with bed and bank is more which leads to loss of stream energy. More friction means more erosion in the banks of the river where sand predominates. Moreover, loss of energy means more aggradation. The hydraulic radius supports this fact that the river is aggrading in character in Mekhlipara where vast flood plain is present along its left bank.

The bank is very steep (nearly perpendicular) from bank top up to 4 m and after that the basal slope exist with gentle slope. Steeper slope contribute to sediment transport and to bank erosion and are often associated with coarse heterogeneous materials [12]. Non-cohesive bank material i.e., sand dominates the bank with maximum percentage at 2 - 4 m depth (90%), leads to maximum erosion which ultimately leads to widening of the channel. The lower part of the original bank is not visible during the field survey due to the presence of soils deposited through bank failure. Therefore the basal portion is protected from erosion, though during monsoon season with increase in water level and velocity, this portion usually removed and the original bank with non-cohesive materials gets direct attack of the river velocity.

Again, human intervention in the form of sand collection from the channel bed leads to deepening of the channel which is again supplemented by materials from the bank toe. This anthropogenic activity is also responsible for the weakening of the non-cohesive soil at the bottom of the bank and ultimate failure of the upper portion during rainy season. Local people are of the opinion that bank failure has increased in recent years due to such activity.

Moreover, Mekhlipara site shows a vast barren land which is also another reason behind the presence of wider channel. Vegetation cover, especially the role of root networks may reinforce bank materials, thereby increasing resistance to erosion [8, 10]. If discharge, slope, bend curvature, bank texture and bank heights are constant, a river migrating through cleared or

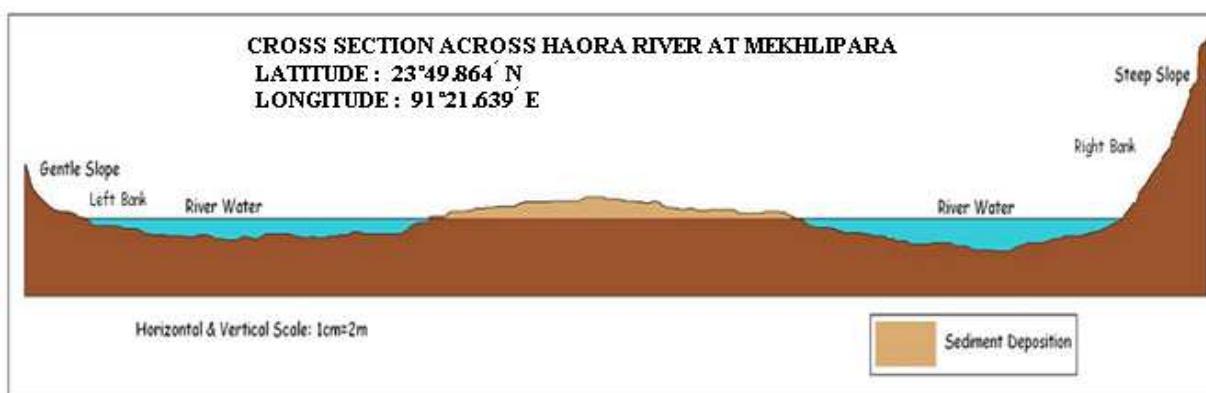
Fig. 4: Cross-section across the River Haora at Mekhlipara

Season : Pre-monsoon
Water width : 28 m
Average Depth : 0.0152 m
Cross Sectional Area : 12.40 m <sup>2</sup>
Wetted Perimeter : 20 m
Hydraulic Radius : 0.62 m

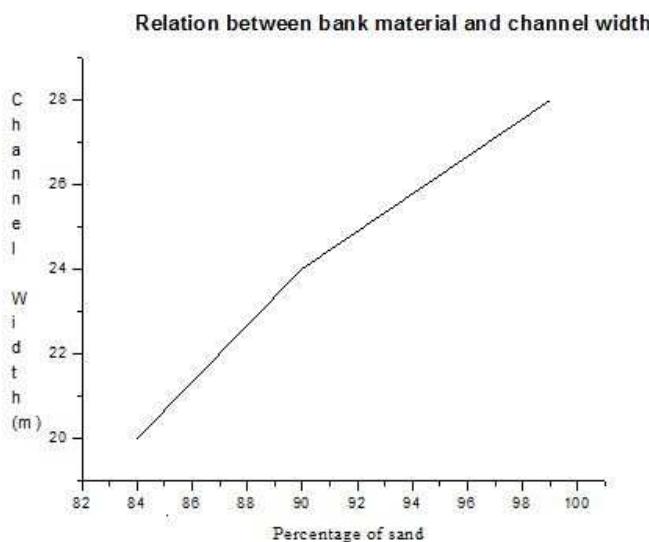
**Fig. 5: Relation between bank material and channel width**

The above study in a part of Haora River shows strong relation between nature of bank material and channel character. The presence of high percentage of sand in the middle portion or bottom of the bank leads to much wider channel with bar deposition within the channel (mid-channel bar) or adjacent to the bank (point bar), thereby decreasing the depth and wetted perimeter of the channel. Though all the three sites are vulnerable to bank erosion, Mekhlipara is the most vulnerable due to the presence of maximum amount of non-cohesive sand (90%) in the bank just above the basal slope (2 – 4 m).
