Archives of Applied Science Research, 2015, 7 (7):27-36
(<http://scholarsresearchlibrary.com/archive.html>)

Impact of anthropogenic activities on channel characteristics: A case study of Muhuri River, Tripura, North-East India

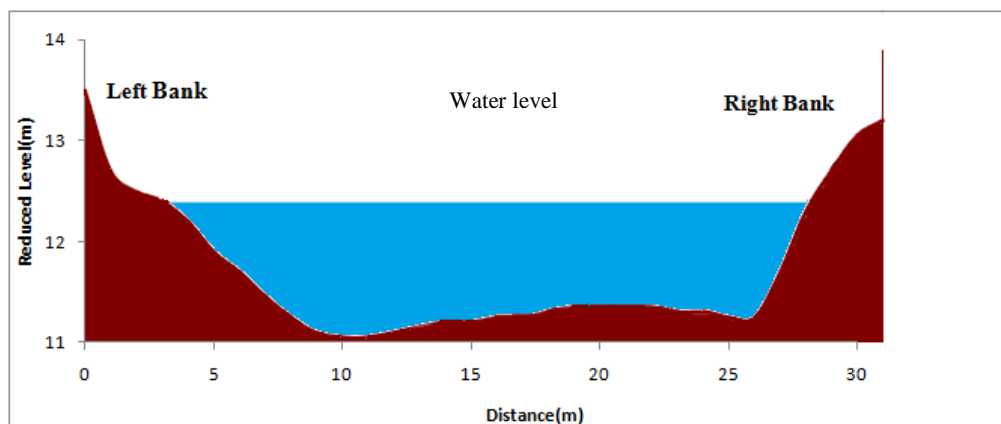
Fig.2: Cross section across the Muhuri River upstream of the barrage located at Kalashi

Huge volume of water has been trapped behind the barrage to provide water for irrigation. The study shows that the variables like average depth, discharge and wetted perimeter of the Muhuri River are higher in upstream of the barrage (Fig.2) whereas markedly decreased in the downstream portion (Fig.3) by 88.44%, 82.99% and 44.55% respectively (Table1). The bridge and barrage play a significantly important role in the river environment and river morphological features [6]. Due to decrease in discharge (82.99%), the competency and capacity of the Muhuri River to transport load has also decreased remarkably in downstream of the barrage. These results in the formation of various stable and unstable bars, creates downstream water scarcity, char lands etc (Fig.5).

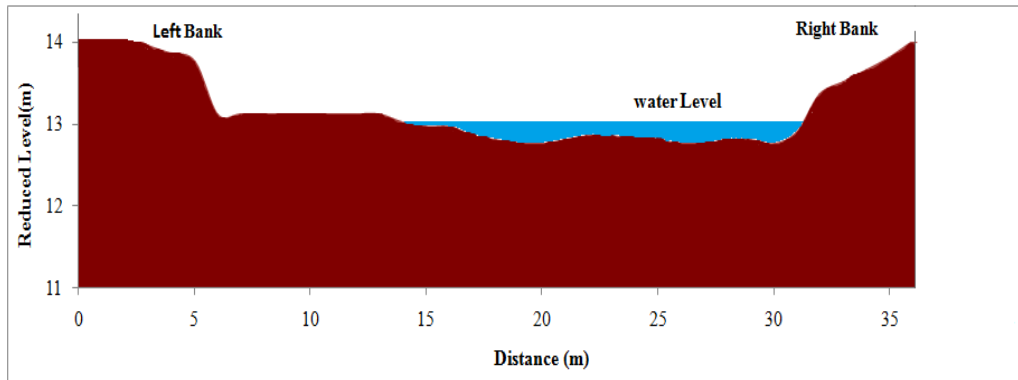
Fig.3: Cross section across the Muhuri River downstream of the barrage located at Kalashi

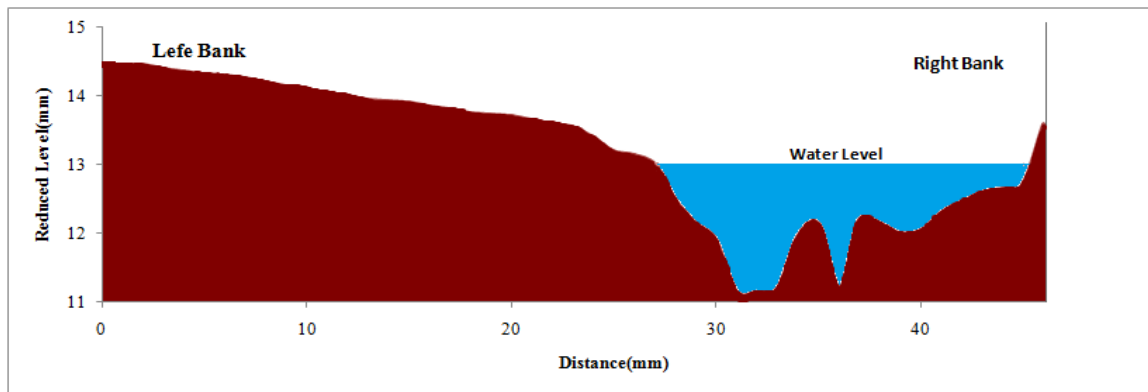
Fig.7: Cross section across the Muhuri River at the sand collection points near Jolaibari

Extraction of sand from the Muhuri River bed near Jolaibari is going on for a long period of time to use for constructional purposes. It has negative impact on channel characteristics which can easily be analyzed by comparing the channel at the sand collection site and immediate upstream of that site. Depth of the river is very high at that part of the bed from which sand has been extracted (Fig.7). As a result the rate of scouring at that part becomes very high due to the formation of eddies, especially during high discharge. This creates instability in the bed and bank. Extraction of bed material from an active riverbed may trigger changes in many factors governing fluvial processes, disturb the sediment balance and alter the erosion and sedimentation patterns [4].

Table 2 indicates the increasing instability of the river bed and bank in the sand collection site at Jolaibari where 360% increase in channel depth near the left bank has been identified. Mining and its associated activities can also be responsible for considerable damage of river morphology. Physical impacts of sand mining include deterioration of water quality and destabilization of the stream bed and banks. Mining can also disrupt sediment supply and channel form, which can result in a deepening of the channel (incision) as well as sedimentation of habitats downstream [5]. Now a day an unscientific way of sand collection is practiced using pipe and motor from side of the river bed, which pose threat to river bank stability.

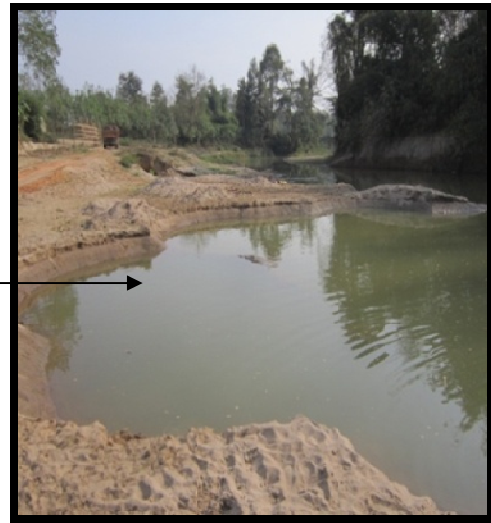
Plate 1: Changed thalweg line of the Muhuri River at sand collection point near Jolaibari

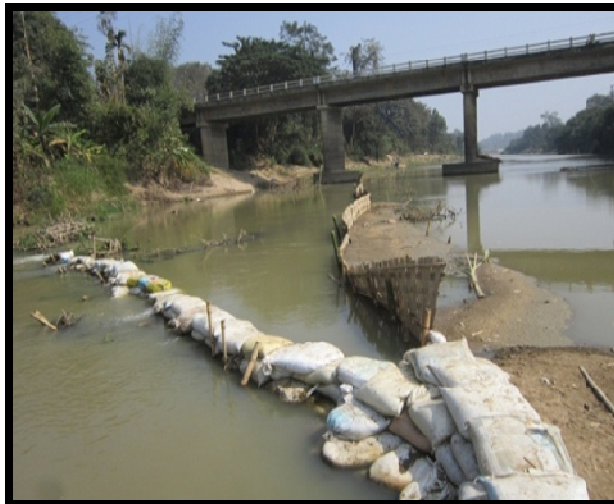
Plate 2: Obstruction in natural flow of the Muhuri River to store water for the purpose of drinking water supply near Muhuripur

River water is one of the major sources of drinking water. With decrease in rainfall and fall in ground water level, the dependency on river for drinking water is increasing. Several treatment plants are operating along the bank of the Muhuri River to purify the river water for drinking purpose. For this purpose the natural flow of the river has been obstructed by placing heaps of cement bags to store water near the treatment plants (Plate 2) which affect the downstream characteristics of the river.

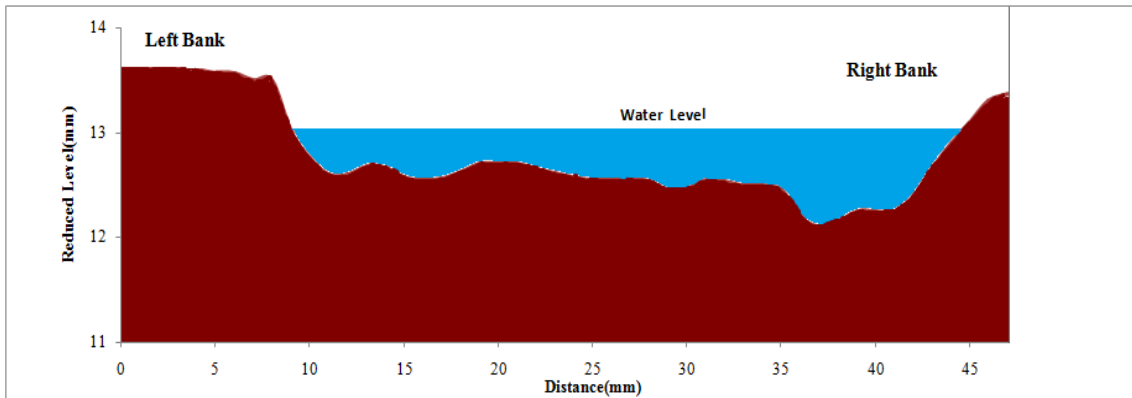
Fig.9: Cross section across the Muhuri River in upstream of the obstruction site near Muhuripur

It has been observed near various treatment plants located at different parts of the River Muhuri. In this paper changing characteristics of the Muhuri River near Muhuripur treatment plant has been analyzed. For that purpose two cross sections have been taken across the Muhuri River in immediate upstream and downstream of the Muhuripur treatment plant (Fig. 9 and 10). This shows marked change in characteristics of the river

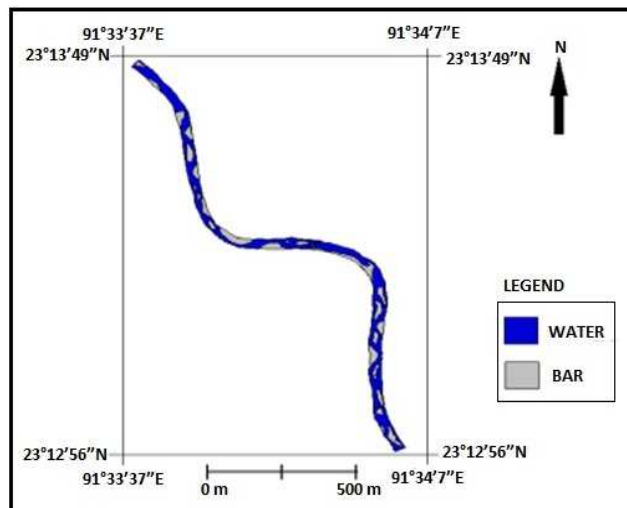
Fig.11: Formation of large number of bars in downstream of the obstruction of natural flow area near Muhuripur

Before the obstruction of natural flow the river water is relatively stagnant. Due to decrease in discharge (26.47%) the ability of the river to carry load has also decreased. As a result lots of point and mid channel bar have been formed in downstream of the obstruction site (Fig.11). This clearly indicates the changing character of the river due to human intervention.

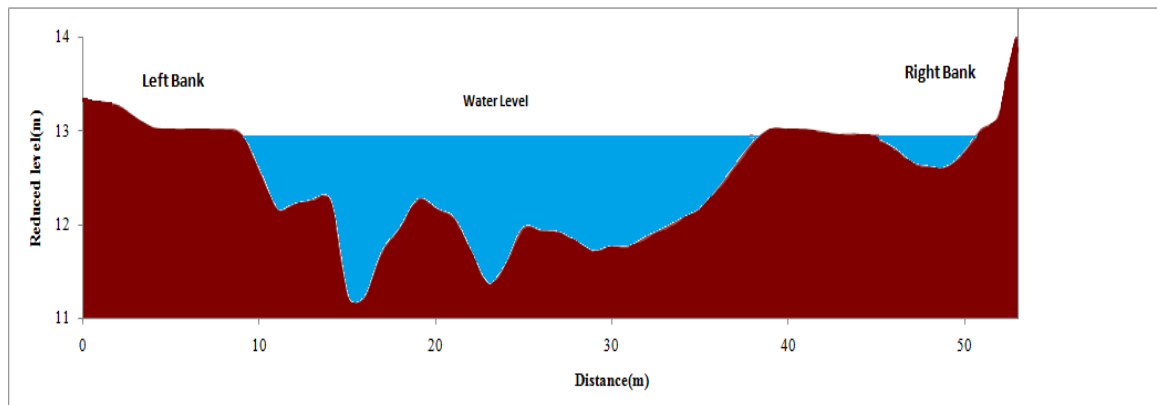
Fig.12: Cross section across the Muhuri River in immediate upstream of the site of constructional work for rail bridge near Belonia

Due to this narrow passage, huge volume of water remains stagnant immediate upstream of the construction site which results in increase of depth, discharge and wetted perimeter. As a result in the upstream of the site various pot holes have been formed due to scouring of running water in the left bank side. Again, lots of point and mid channel bar have been formed immediate downstream of the construction site by the effect of sedimentation due to decrease in discharge (45%) and channel depth (74.03%).

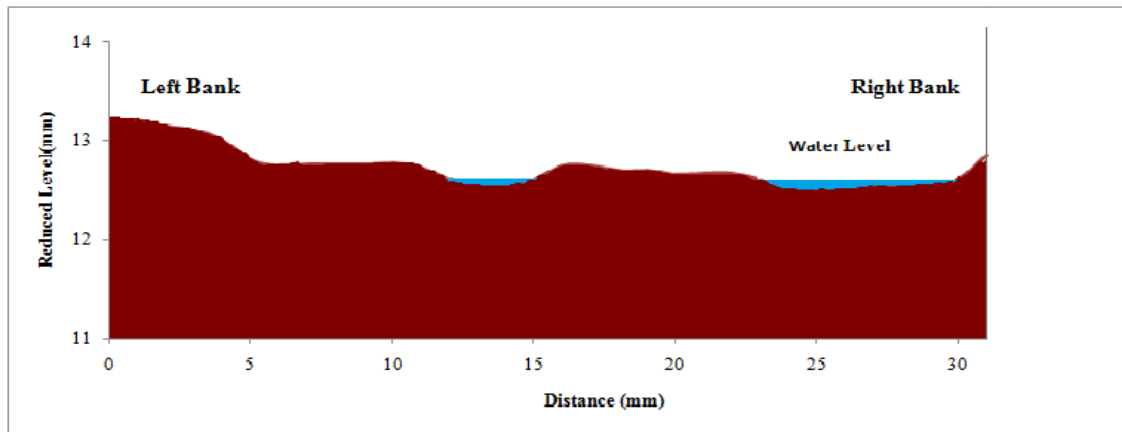
Fig.13: Cross section across the Muhuri River in immediate downstream of the site of constructional work for rail bridge near Belonia

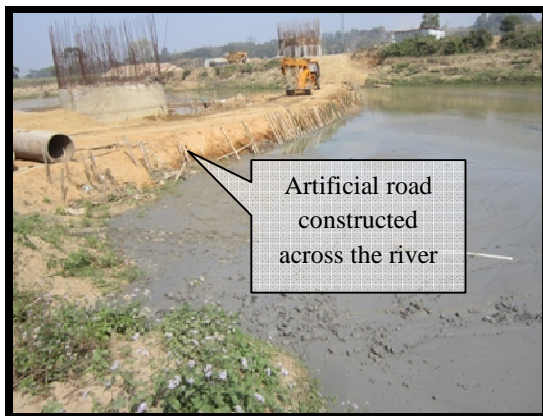
Plate 4: Sediments are deposited in the downstream section of the constructional site due to the construction of artificial road across the river

During field visit it has been observed that the nature of the river at Manurmukh area (in Belonia) is badly affected by the constructional work of Rail Bridge. Here, soil materials are extracted from river bed through boring holes and are dumped across the pillar to construct bridge. Moreover, the waste and cement materials used for construction purpose are dumped across the channel. Consequently, depth of the river is gradually decreasing in the study area.

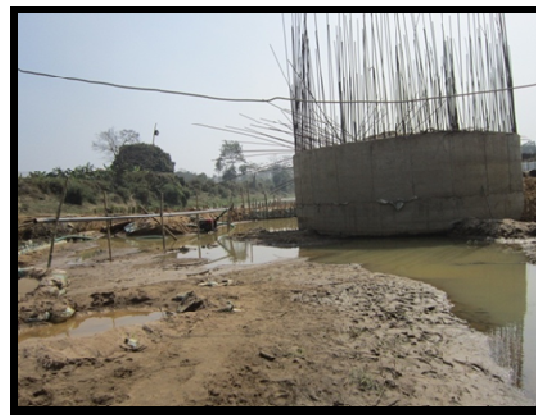
Plate 3: Construction site of Rail Bridge where the channel is blocked by an artificial road near Belonia

The bridge and barrage play significantly important role in the river environment and river morphological features. River water flow, sediment distribution and wave regulation largely rely on bridge on the river [6]. The Central Government has taken over various constructional works for establishing railway lines in Tripura. One of the most important constructional works is going on across Muhuri River at Manurmukh, Belonia since last two years. This is one of the biggest constructional works on the Muhuri River. In this site a kachha road has been constructed from left bank to right bank, which disturbs the normal flow of the river (Plate 3). As a result the width of the river at the construction site has reduced to only 9m, whereas earlier it was 36 m, i.e. 75% decrease in channel width.
