Archives of Applied Science Research, 2011, 3 (6):369-376
(<http://scholarsresearchlibrary.com/archive.html>)

Remote Sensing and GIS for Soil Erosion Prone areas Assessment: A case study from Kalrayan hills, Part of Eastern Ghats, Tamil Nadu, India

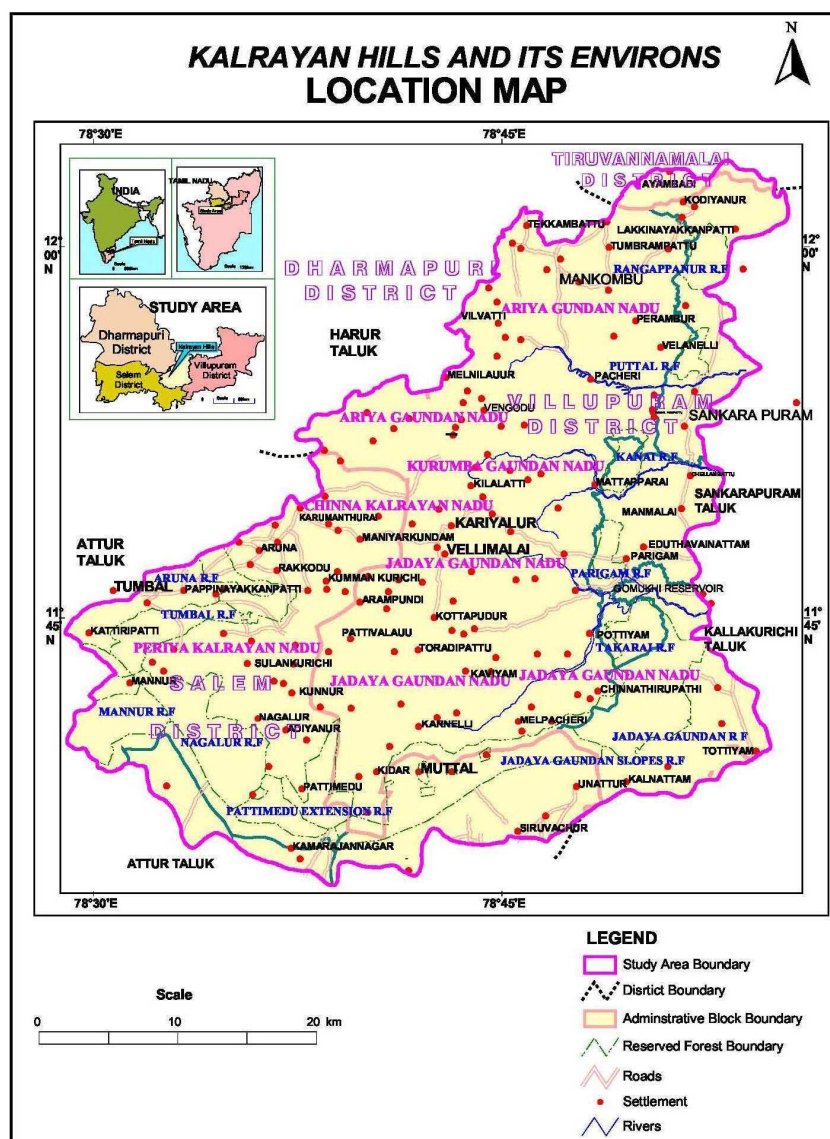
Fig.1

The study area, the Kalrayan hills, part of Eastern Ghats, lies between the north latitudes $11^{\circ} 36'$ and $12^{\circ} 01'$ and the east longitudes $78^{\circ} 29'$ and $78^{\circ} 54'$ (Fig.1). It forms part of three districts viz. southern and southwestern portion of Salem, the central and eastern portion of Villupuram and a small part of Thiruvannamalai district occupied by the northern most part of the study area. The Kalrayan hill is divided into '5' nadus (means group of villages, such as Periyakalrayan (western part), Chinnakalrayan (northern part), Jadaya gaundan (southern and eastern part), Kurumba gaundan (central part) and Ariya gaundan (North) and encompasses 79 revenue villages(Fig.1). It acts as catchment for Gomukhi, Kariakovil and Manimuktha nadhis. It supports life to more than one lakh people those who have been living in and around the Kalrayan hills (Sakthivel, 2003 and 2006). The Vegetation types of Kalrayans are scurb jungles existed at an altitude of 500m, and the deciduous forests are situated between 800 to 1300m. The shoals are the sheltered pockets occurred on the plateau (Matthew, 1981). The study area is encircled by Sathanoor dam, in the north, the famous Attur valley in the south, Manimuktha dam in the East and Chitterin hills in the west. The average rainfall in the study area ranges from 782.98 to 1787.20mm. The temperature varies from a minimum of 25°C to a maximum of 40°C . The altitude varies from 126 to 1298m. The study area is composed of seven soil types and varies from red-loam to black clay (Kadavul and Parthasarathy, 2001). In the study area numerous lineaments and their points of intersection have been identified and most of them show NE-SW trending direction (Sakthivel *et al.*, 2003). A prominent shear zone trending in a N-S direction cut across the entire hills (Sakthivel *et al.*, 2010)

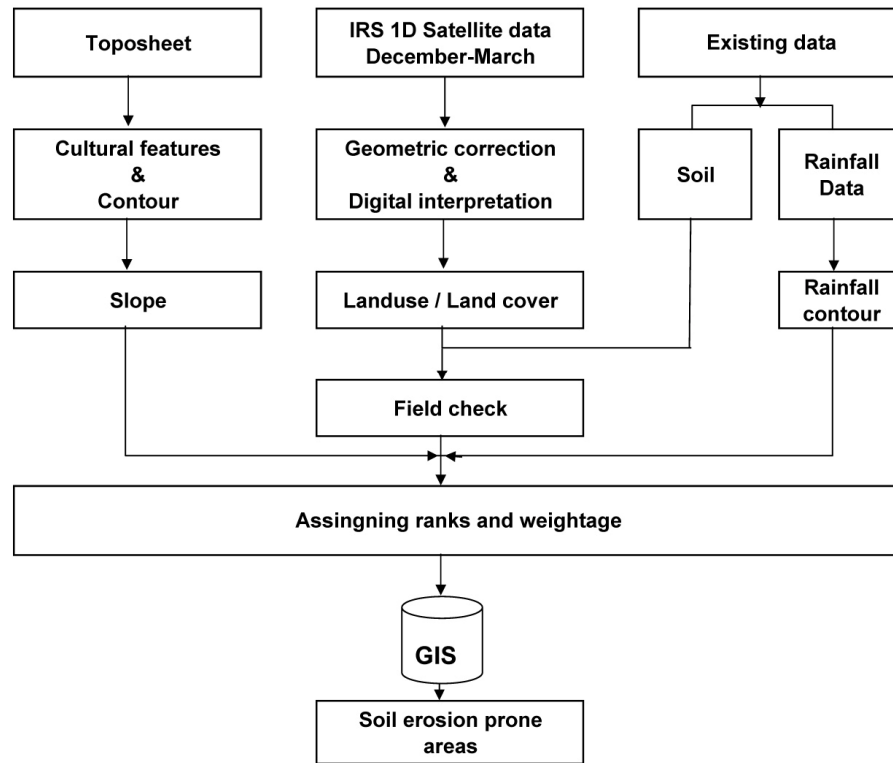
The following schematic diagram shows the methodology of the present work.
