Archives of Applied Science Research, 2016, 8 (5):70-76 (http://scholarsresearchlibrary.com/archive.html)

# Flood control measures: mapping encroachments along the river Kaveri in Tamil Nadu, Thanjavur District, India

Key words: Encroachments, GPS, Flash Flood

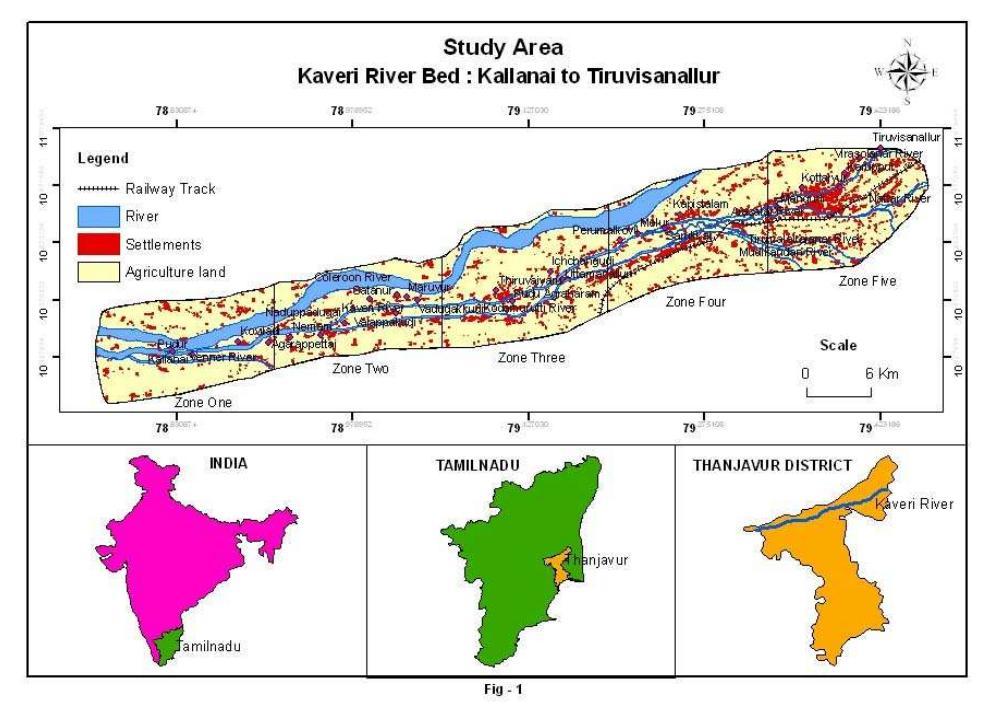
To study the encroachments along the river bunds, from Kallanai to Tiruvisanallur at a stretch of 77 kilometers have been taken to study the above problem of flooding during heavy rainy seasons and marooning several villages along the rivers. Figure-1 shows the sample Kaveri river bed, which has been divided into five zones and the first consisting of seventeen kilometers and the rest of the four zones consisting of fifteen kilometers to show details of the ecroachments along the river courses. In the figure apart from settlements, agricultural lands and river channels are also shown.

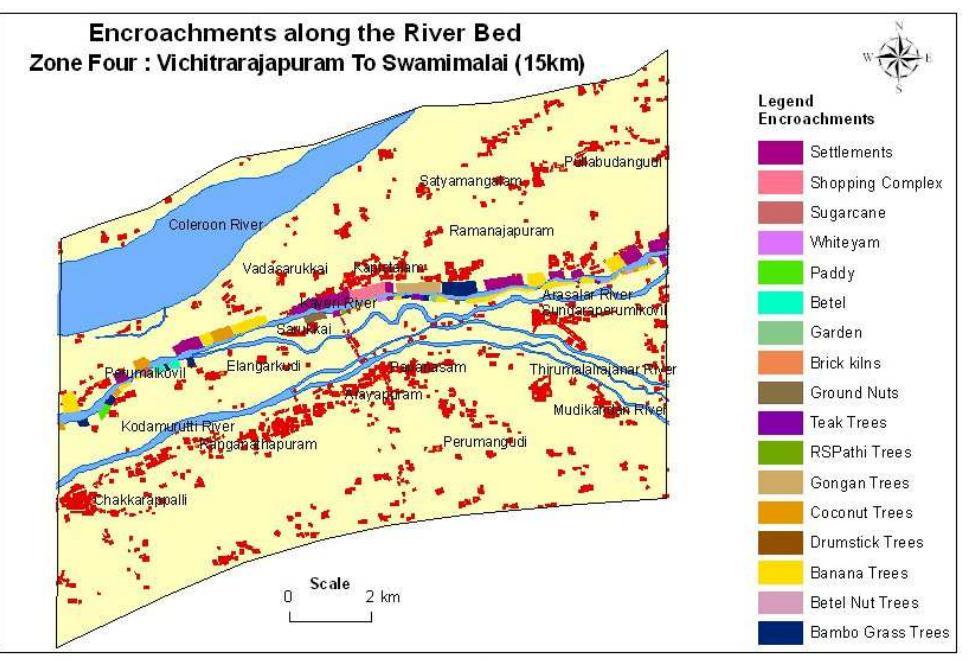
Fig - 2

Figure-2 and table-4 gives the details of zone four for a length of 15 kilometers from Vichitrarajapuram to Swamimalai. As the river proceeds to the nearby urban centers the encroachments are increasing in area and the type such as shopping complexes and settlements apart from the agricultural activities. The details of encroachments and the measurement details are given in table-7. Brickline along the river course poses a major obstacle because the clay from the bunds is taken and the bricks are manufactured. Due to this reason, taking more bund clays reduces the height of bunds and allows the free flow of excess water to the nearby villages during seasonal heavy rainfall.

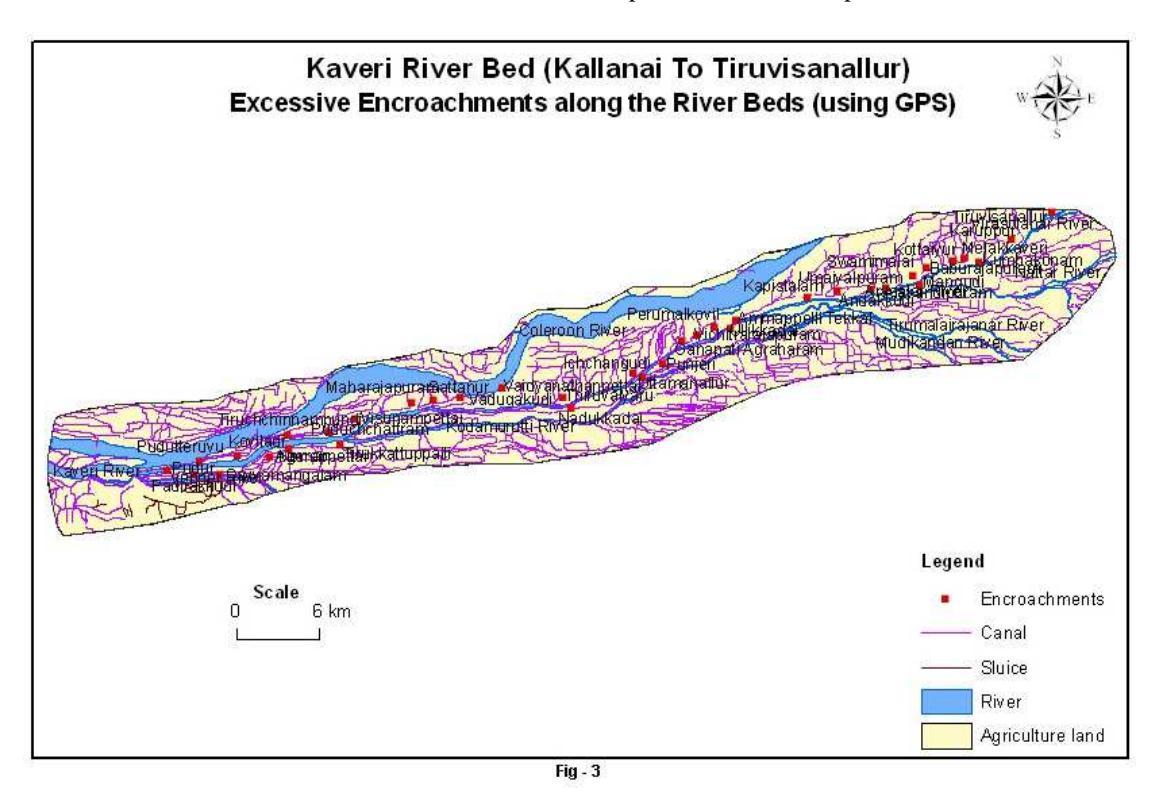
Figure-3 and table-6 shows the entire Kaveri river bed stretches from Kallanai to Tiruvisanallur exclusively surveyed for settlement encroachments for more than 60 houses using GPS. In the map each dot represents the presence of more than 60 unauthorised construction of houses/ permanent and semi permanent.
